**Flood Control Project Maintenance
Levee Inspections**

Maintenance Issue Types Only, Levee Inspection Report By Mile - Spring 2020

Reclamation District No. 2094 Walthall

Waterway	Bank	Unit Miles	Inspection Start/End	Inspector
Unit No. 01 San Joaquin River	Right	2.78	03/24/2020 03/24/2020	Alberto De Leon

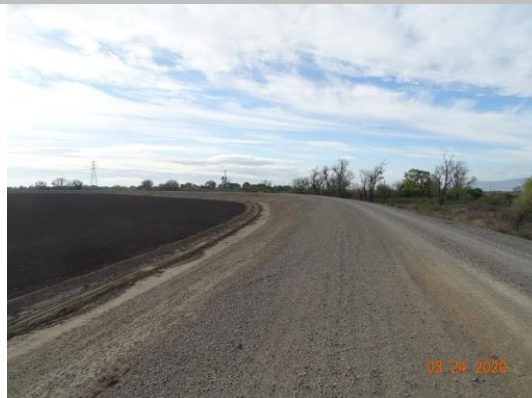
Photo 1 of 1 : SP_2020_RD2094_320_6_20200324_00017.jpg

LM Start	1.79	Rating **	A	Issue No.	6
LM End	1.79	Issue Type +	Ma	Location *	LS
Category	Earthen Levee			GPS Latitude/Longitude	
				Start	End
Item	Vegetation			37.754510 °	37.754510 °
				-121.302868 °	-121.302868 °
DWR ID	DWR_RD2094_01_s_2020_6				
Comment Code					
V1 : Control annual grass and weeds on the levee slopes and easements.					
Inspector Comment

Typical view of well maintained vegetation on landside slope. Spring 2020

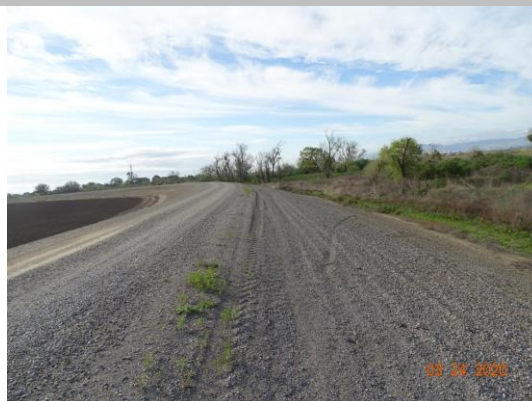
Photo 1 of 1 : SP_2020_RD2094_320_7_20200324_00018.jpg

LM Start	1.79	Rating **	A	Issue No.	7
LM End	1.79	Issue Type +	Ma	Location *	WS
Category	Earthen Levee			GPS Latitude/Longitude	
				Start	End
Item	Vegetation			37.754510 °	37.754510 °
				-121.302868 °	-121.302868 °
DWR ID	DWR_RD2094_01_s_2020_7				
Comment Code					
V1 : Control annual grass and weeds on the levee slopes and easements.					
Inspector Comment

Typical view of well maintained vegetation on waterside slope. Spring 2020

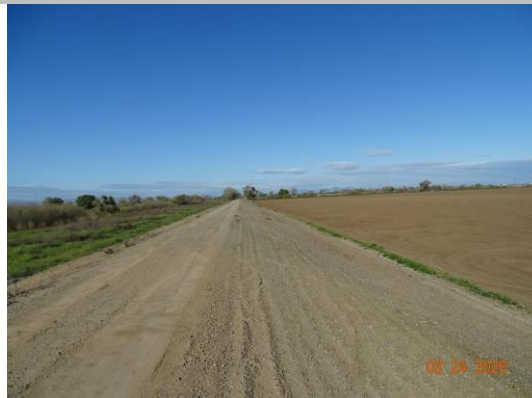
Photo 1 of 1 : SP_2020_RD2094_321_1_20200324_00002.jpg

LM Start	0.20	Rating **	A	Issue No.	1
LM End	0.20	Issue Type +	Ma	Location *	LS
Category	Earthen Levee			GPS Latitude/Longitude	
				Start	End
Item	Vegetation			37.760619 °	37.760619 °
				-121.302748 °	-121.302748 °
DWR ID	DWR_RD2094_02_s_2020_1				
Comment Code					
V1 : Control annual grass and weeds on the levee slopes and easements.					
Inspector Comment

Typical view of well maintained vegetation on landside slope. Spring 2020

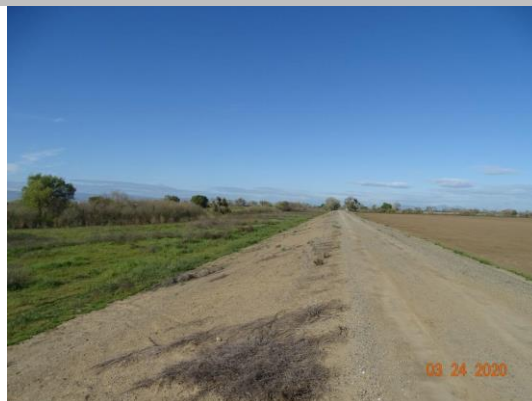
Photo 1 of 1 : SP_2020_RD2094_321_2_20200324_00001.jpg

LM Start	0.20	Rating **	A	Issue No.	2
LM End	0.20	Issue Type +	Ma	Location *	WS
Category	Earthen Levee			GPS Latitude/Longitude	
				Start	End
Item	Vegetation			37.760619 °	37.760619 °
				-121.302748 °	-121.302748 °
DWR ID	DWR_RD2094_02_s_2020_2				
Comment Code					
V1 : Control annual grass and weeds on the levee slopes and easements.					
Inspector Comment

Typical view of well maintained vegetation on waterside slope. Spring 2020
